By CWO3 Dave Cerda, USS Mount Whitney (LCC 20)

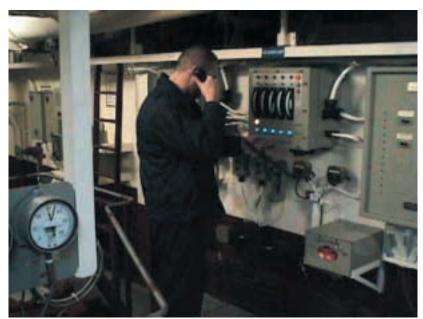
This operator understands how a ship's list-control system works. A fireman apprentice assigned to clear some danger tags on pumps in a similar system, however, wasn't familiar with what he was doing.

Investigators cited the improper clearance of the danger tags as one cause of this mishap. Did the supervisor know the fireman apprentice wasn't familiar with the system? Why didn't the fireman apprentice tell his supervisor he wasn't sure what he was supposed to do? As a supervisor, do you allow your people to speak freely about maintenance and training issues?
